Mitigating Newton Rings when scanning Jacketed Fiche

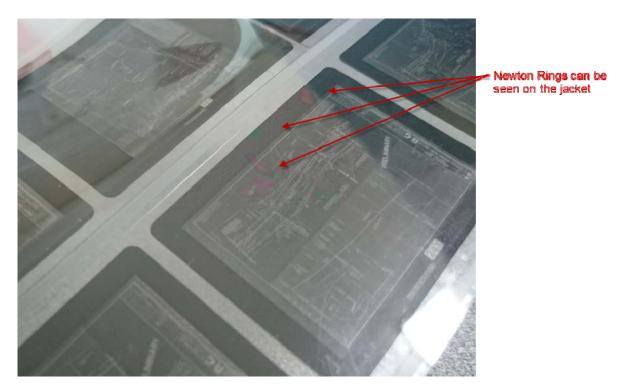
Newton Rings are caused by the reflection of light between a spherical surface and a flat surface and the interference it encounters. For a full discussion please visit the following <u>link</u>. When a piece of film is inserted into a jacket, the thin clear film of the jacket will not adhere perfectly to the surface of the microfilm causing a slightly spherical surface adjacent to a flat surface. Newton Rings can be seen with the naked eye and appear as rainbow patterns similar to the ones shown in the picture below.

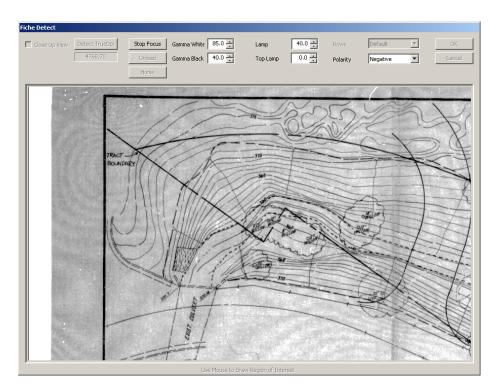
When the jacket is loaded into a scanner they are typically sandwiched between plates of glass. While the plates are designed to insure the film is flat (within the depth of field of the lens) for proper focus, it is not designed to insure that the jacket is adhered perfectly to the film. It would require a vacuum system to have the two surfaces flat or a roller system.

The end result is that the rings will show up in the scans like the picture below:

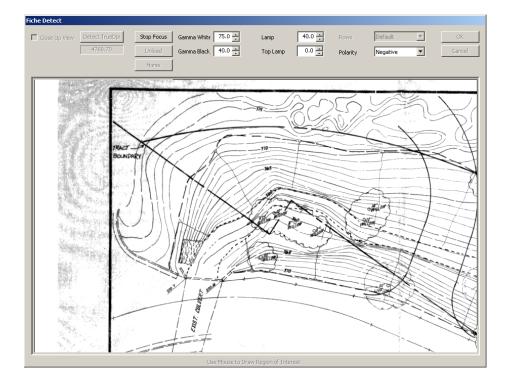
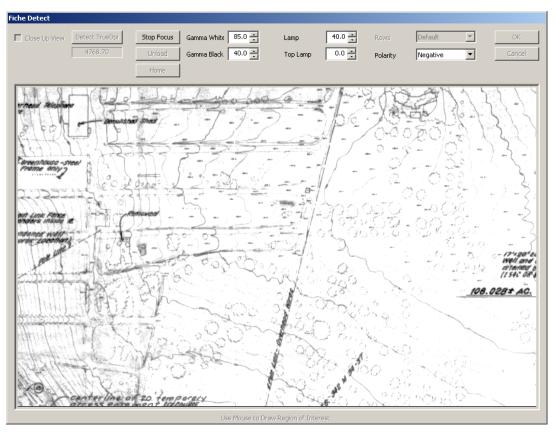
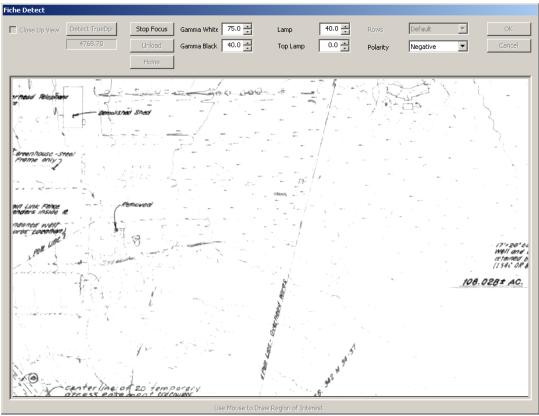
An attempt can be made to lighten the image to minimize the impact of the rings, but often it results in data being eliminated elsewhere in the scan.
